# Alloy 800 HT Extruded-Pipe Cracking

By: Hanna Lebamoff (OSU), Morgan McGraw (OSU), and Georgia Wiswesser (OSU)

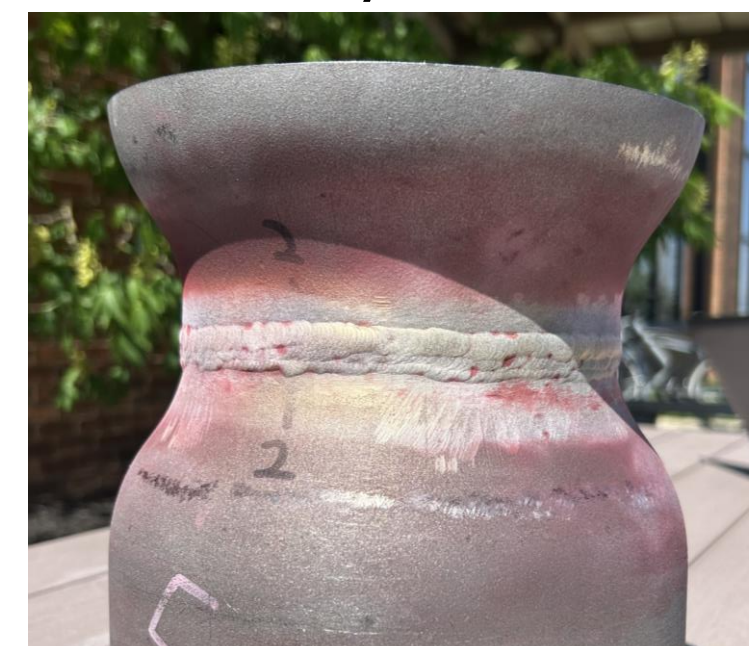
### Task 2.2 Dye Penetrant

Pass: No cracking occurred in area of interest
