## Background

While not explicitly required by code, GE Aerospace stores their Ti filler in baths of argon to prevent oxidation prior to welding. To move toward more sustainable practices, GE Aerospace requested that the necessity of storing their filler wire in argon be investigated to potentially remove the requirement from their internal standards and to save costs on argon expenditures.

## Objectives & Approach

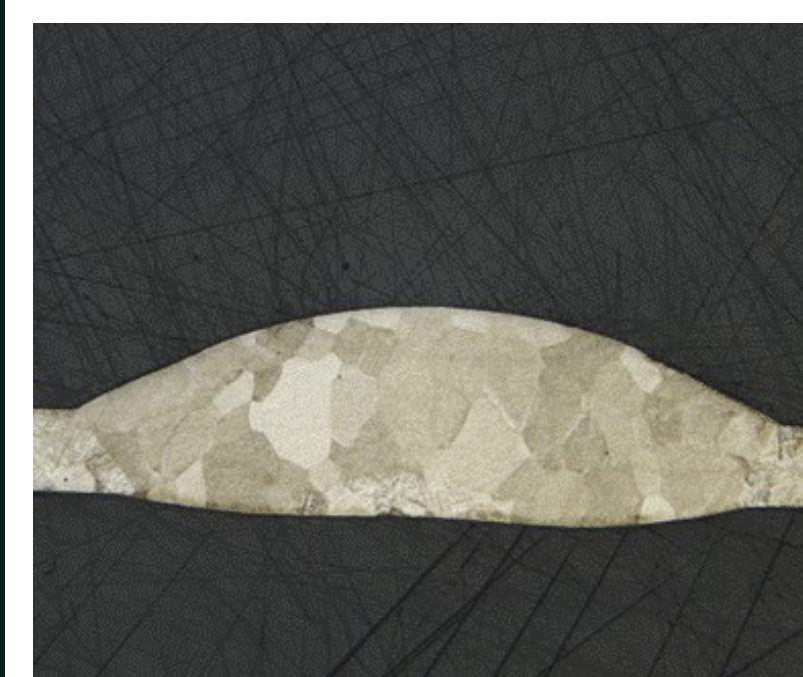
Figure 1 - Control Sample Cross Section

- Control samples established a sound baseline, though minor preparation artifacts (e.g., over-etching) highlighted limitations in interpretation.
  - Torched samples exhibited the greatest variability, including **isolated defects such as toe cracking, lack of fusion, and reinforcement**, but these were not consistently observed across all samples. One torched sample showed **possible  $\alpha'$  (alpha-prime) formation along  $\beta$  grain boundaries**, indicating localized microstructural transformation without catastrophic degradation.

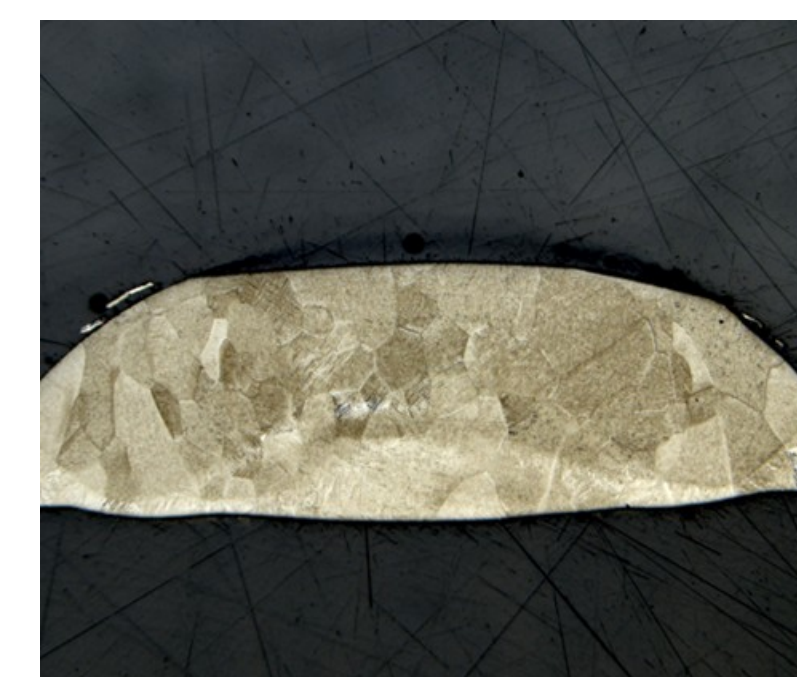
Figure 2 - Torched Sample 1

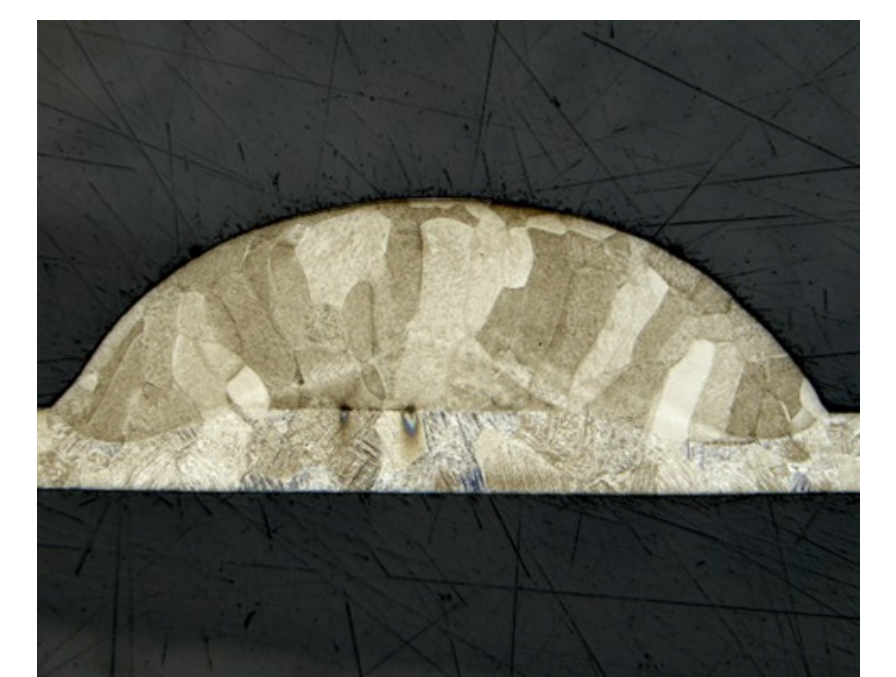
Figure 3 - Torched Sample 2

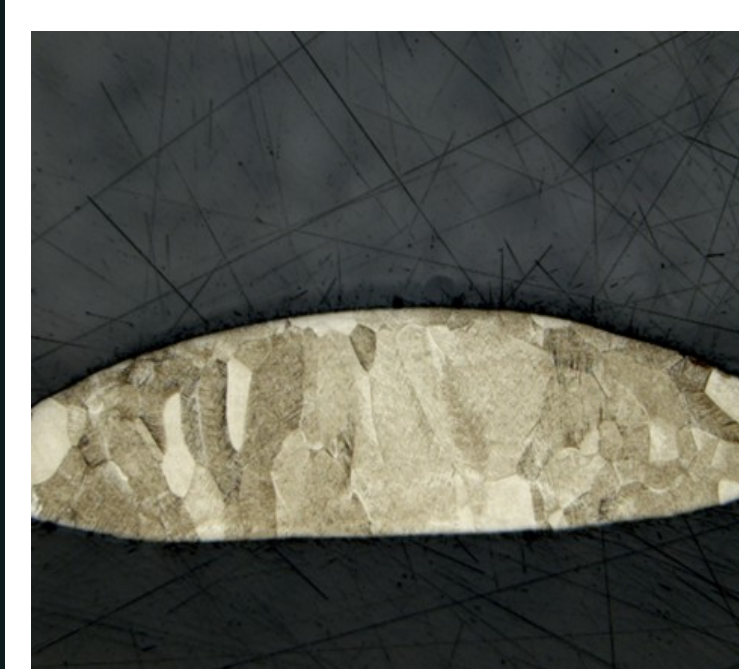
Figure 4 - Torched Sample 3

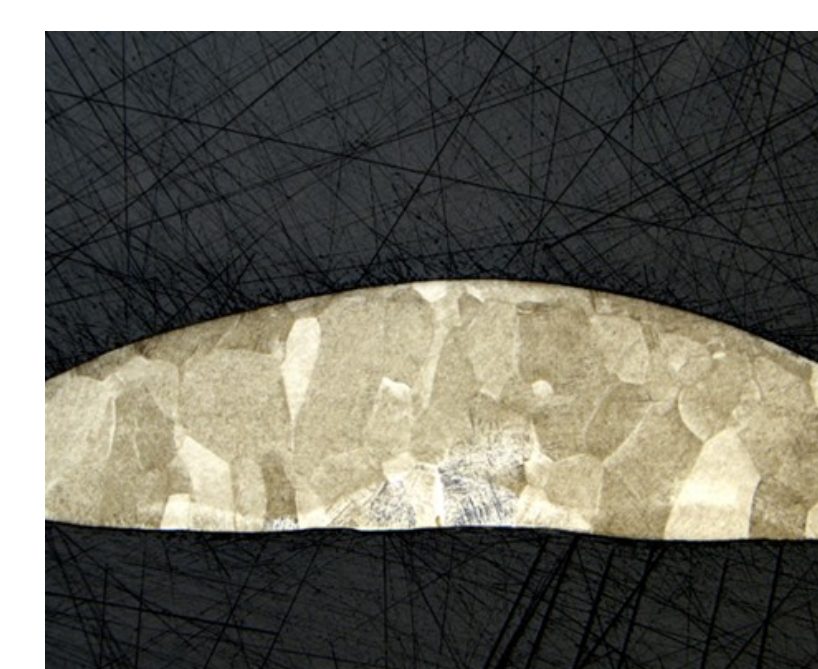
Figure 5 - Water Sample 1

- Water-exposed samples also produced **acceptable welds**, though some showed **reduced dilution and increased reinforcement**, similar to torched samples. Importantly, strong-performing samples within this group suggest that **water exposure alone does not directly correlate with poor weld quality**.

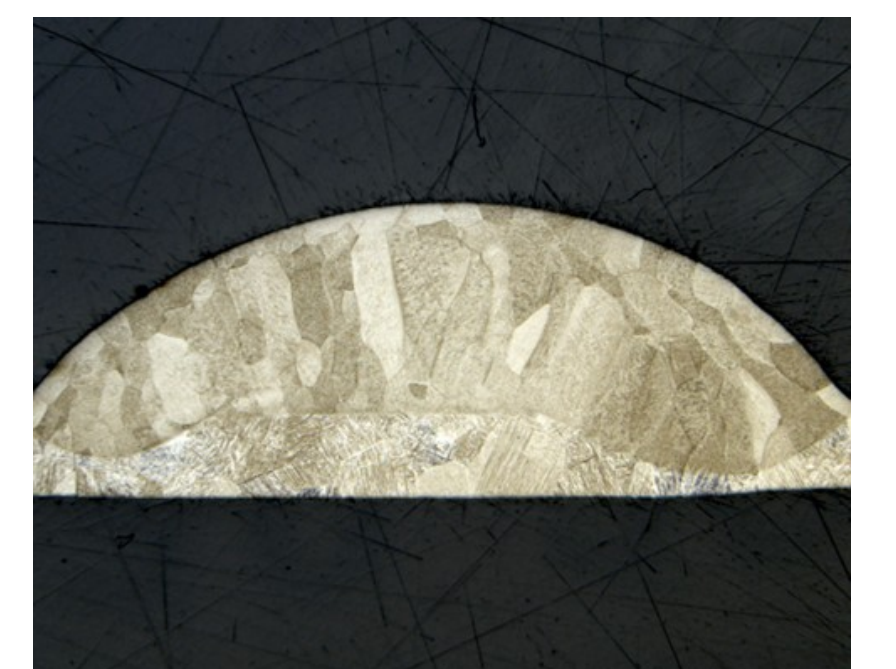
Figure 6 - Water Sample 2
